ONE BLOCK FROM THE WHITE HOUSE - LEAKER IDENTIFIED AND CAUGHT ON VIDEO

Washington DC, USA, November 2017,
In order to detect possible leakage and evaluate the general pipeline condition, the District of Columbia Water and Sewer Authority, DC Water, decided to optically and acoustically inspect one of the oldest parts of the Washington DC's drinking water network. A 670m (2,200ft) section of a cement mortar lined cast iron main - installed in 1888 - was subject to be investigated by MTA Pipe-Inspector® multisensory technology.

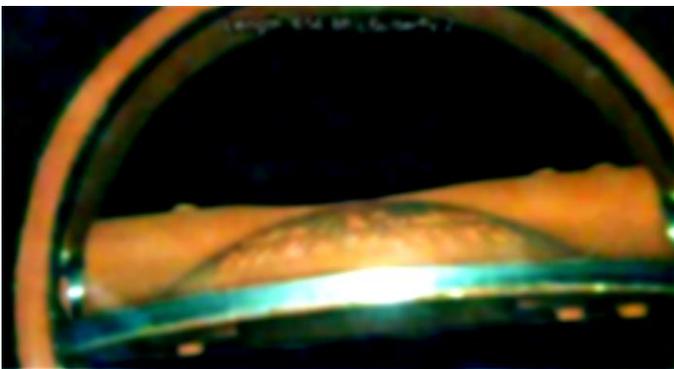
MTA video capture of 1 of 3 inline horizontal butterfly valves

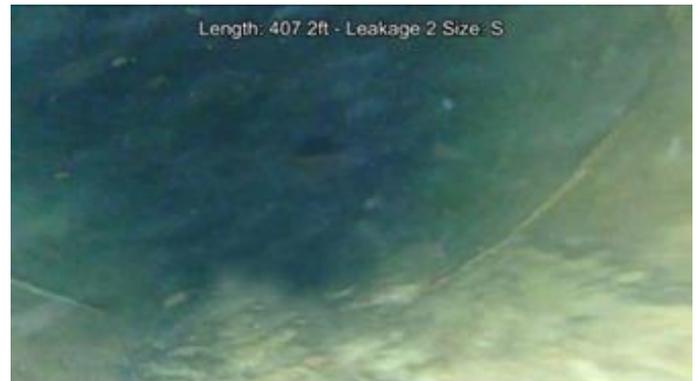
The first identified leak, located near the entry point street intersection, was very small and therefore not deemed to require further actions aside from future monitoring at this point in time. It was located south of a branch line on the right side of the flow direction. The ability to provide a clock position in this case identified the leak as a possible service connection leak.

The second leak, while being rated as larger, yet overall considered to be small, was further down along the pressure pipe. This location was almost equidistant between a branch on one side, and two branch tee connections running perpendicularly in both directions.

Caught on video - synchronized audio/visual reveals leak location

MTA recommended that a water loss analysis should be initiated to quantify the real water loss from the leakages prior to planning for further actions. In addition, to get a total 360 degree detailed optical overview of the interior pipe condition, a second MTA survey could be set up to run along the top side (obvert). Prior to any excavation for a leak, it was recommended that the leak position be verified by another technology, such as geophones or standard leak detection technologies.
